## Safety Alert 106

### Seal Failure – Near Miss Oil Injection

| <b>Document Name</b> | AE-SAS-0006 REV1 Safety Alert - QDS Bolter Seal Failure – Near Miss Oil Injection | | | | |

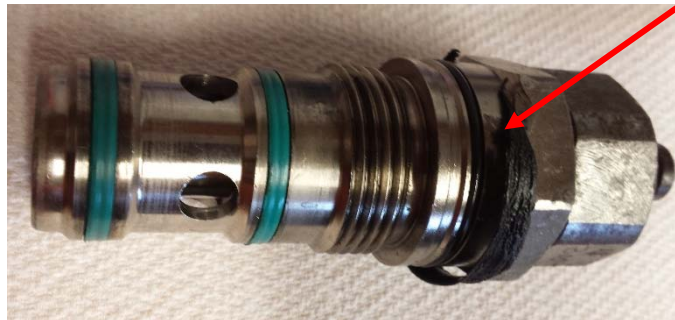
During the operation of a QDS Bolter (fitted with a Hydraulic Controls Valve Bank), an operator was sprayed with hydraulic oil while operating the dead man control on the Valve bank. Upon investigation by the Owner of the bolter it was discovered that a cartridge back-up seal located on the Left Hand side of the valve bank had failed allowing for the escape of high pressure oil in the proximity of the operators hand. The operator was cleared of any injury.

**Failed Back-up Seal**

- Alfabs QDS Boar Bolters are returned to Alfabs for the recommended 2 year overhaul to be completed as per the attached.
- A systematic inspection by End Users / Owners of all exposed cartridges for possible signs of poor integrity of seals/back-ups.
- For Hydraulic Controls Boar Bolters, the Fitting of Guard (BB-102359) to reduce operator exposure.

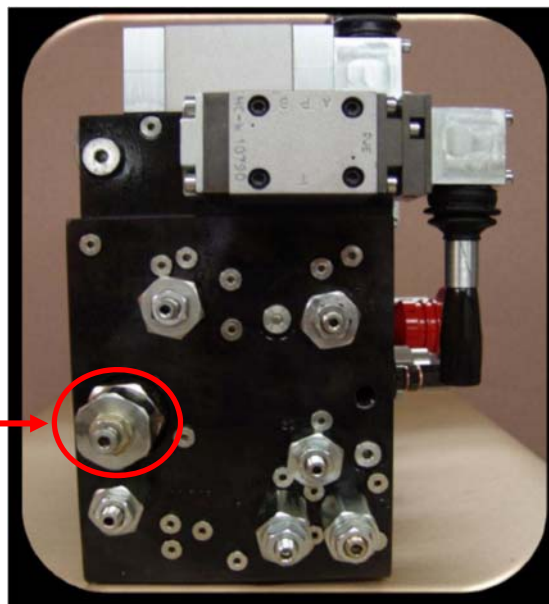
**Failed Cartridge**
