## Safety Alert 106

### Seal Failure – Near Miss Oil Injection

This Safety Alert has been issued to inform the users of Alfabs Equipment the possible risk of injury to personnel caused by the failure of seals used on cartridges installed on the Alfabs QDS BOAR Bolters

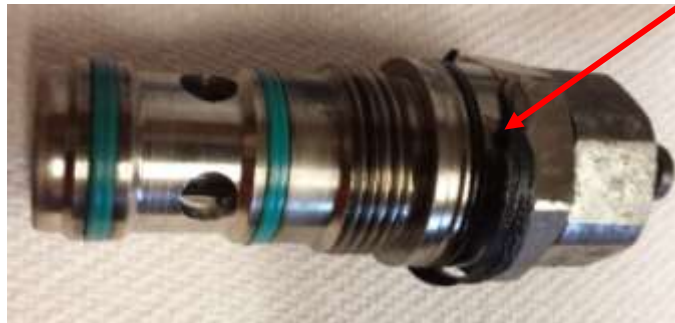
During the operation of a QDS Bolter (fitted with a Hydraulic Controls Valve Bank), an operator was sprayed with hydraulic oil while operating the dead man control on the Valve bank. Upon investigation by the Owner of the bolter it was discovered that a cartridge back-up seal located on the Left Hand side of the valve bank had failed allowing for the escape of high pressure oil in the proximity of the operators hand. The operator was cleared of any injury.

Failed Back-up Seal

- Alfabs QDS Boar Bolters are returned to Alfabs for the recommended 2 year overhaul to be completed as per the attached.
- A systematic inspection by End Users / Owners of all exposed cartridges for possible signs of poor integrity of seals/back-ups.
- For Hydraulic Controls Boar Bolters, the Fitting of Guard (BB-102359) to reduce operator exposure.

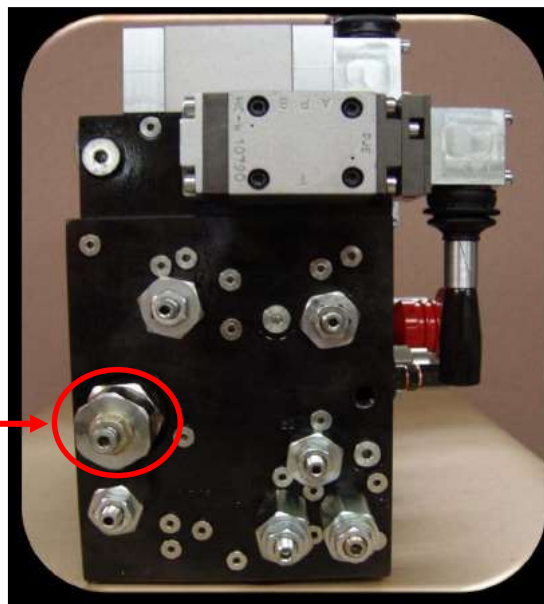
Failed Cartridge
